Conservation Treatment of Station Eight St Chads Cathedral

Birmingham

Author: Naomi Cox for Hirst Conservation Ltd.

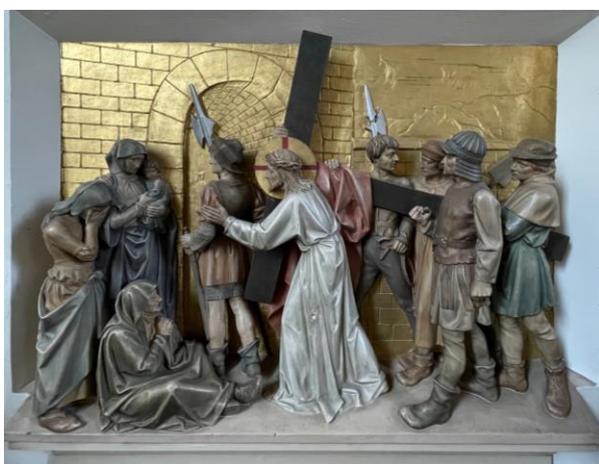
Figure 1: Before Treatment

The treatment conducted included the removal of surface dirt and deposits, stabilising fracture points within the structure, filling and retouching losses, re-instating the Roman Soldier's lance which had previously been removed, and retouching losses within the paint layers on the figures.

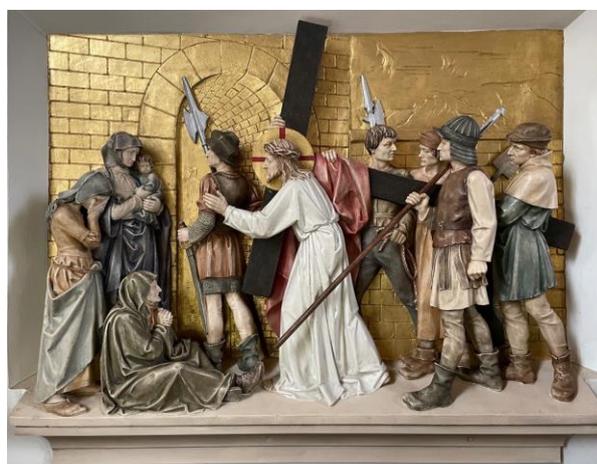
Figure 2: After Treatment

Overall, the treatment of Station 8 was considered to be very successful, achieving a high standard of cleaning, consolidation and replication of missing elements, and it is envisaged that the Station will remain for many years to come.

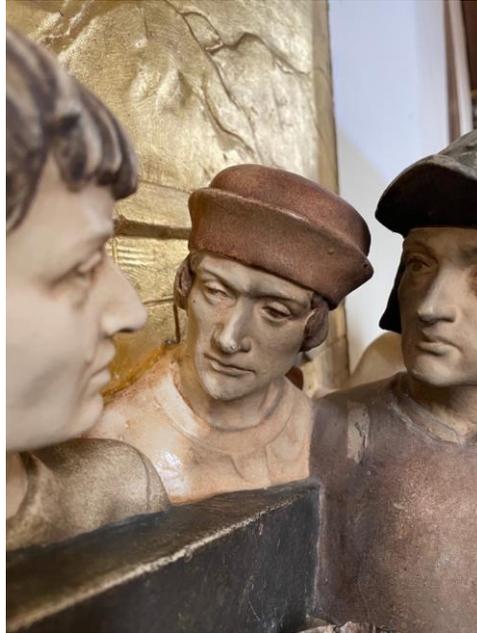
Figure 3: During the cleaning to remove surface dust and deposits

Considerable testing was undertaken to establish an appropriate treatment methodology, and from this a cleaning solution was selected that would gently lift the dirt deposits on the surface of Station 8 without causing damage to the original material or risk of over cleaning. Once the loose dust and debris was removed using a brush and vacuum extraction, this wet cleaning treatment was achieved using damp cotton swab applied onto the surface, with any excess residue of the cleaning solution removed with distilled water on cotton swabs.

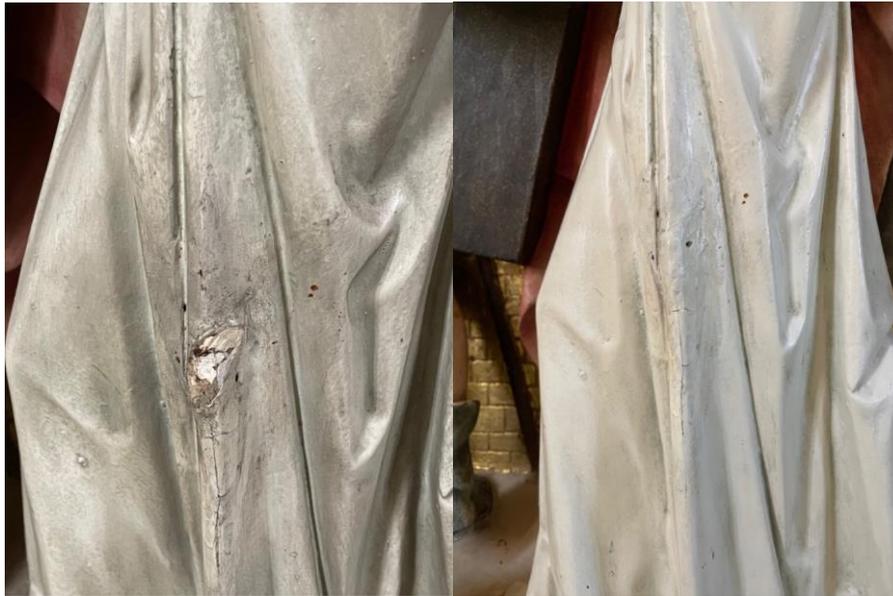
Figure 4: Side by side image of before and after treatment to Jesus's robe

After cleaning was complete, areas of structural damage were repaired, including the fracture point on the upper part of the cross and plaster damage to the robe of Jesus. The upper cross had an original dowel through the centre of the structure and here, the surrounding plaster had detached slightly, causing the fracture point. As the upper part of the cross still maintained a level of structural strength, due to the central dowel, and only minimal movement was evident, it was decided that application of an adhesive within that fracture point would be most suitable for securing the upper part of the cross. Adhering the fracture would provide enough stability to secure the cross in-place whilst maintaining its structural integrity without need for a more intrusive treatment. Another aspect of structural damage to be addressed was the robe of Jesus. As the Station was originally created in plaster, using another form of soft plaster was chosen as it was the most suitable material. Equally, a fill material should always be slightly weaker than that of the original material, therefore in the event of any damage in that area, ideally the repair would fail, instead of the original material. The plaster damage to the robe was repaired with a soft plaster, sanded back to match the surrounding profile, and retouched to create a more harmonious appearance.

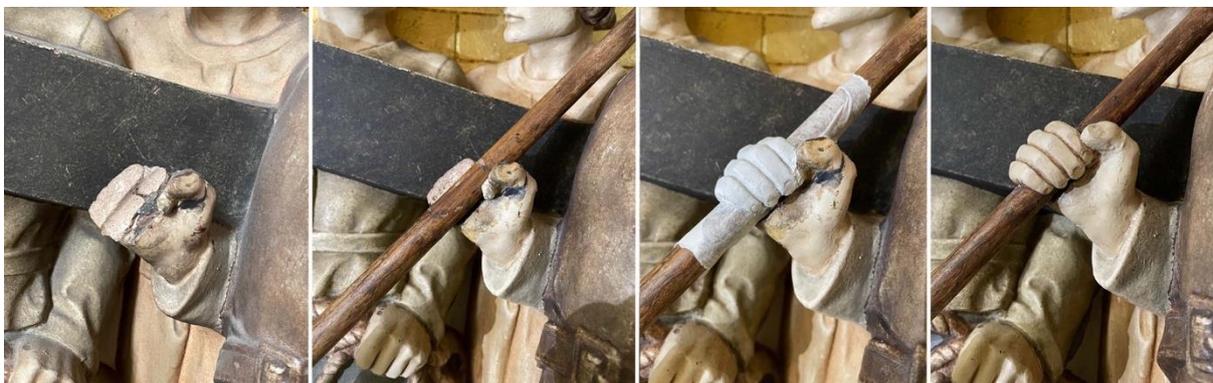
Figure 5: Side by side view of the staged of treatment to the Roman Soldiers hand

The Roman Soldier's hand had also been damaged with the loss of fingers and knuckles. Additionally, a previous repair had been attempted which has since failed. Therefore, the missing areas of the hand were remodelled, replicating the style of the other hands depicted in Station 8. To recreate the hand, modelling clay was used to reconstruct the shape, for which a silicon mould was used to create a cast, and an epoxy putty was used as the casting material. The epoxy putty was selected as it provided a similar texture and colour to the original material. Once in place, it was left to harden and sanded back to ensure a unified join between repair and original material. This method allowed the newly moulded fingers to be reinstated with adhesive applied along the old repair site of the hand, which allows for future re-treatability as well as avoiding damage to the original material by adhering to old adhesive. Once secured, the fingers were retouched to replicate the appearance of other hands in the station.

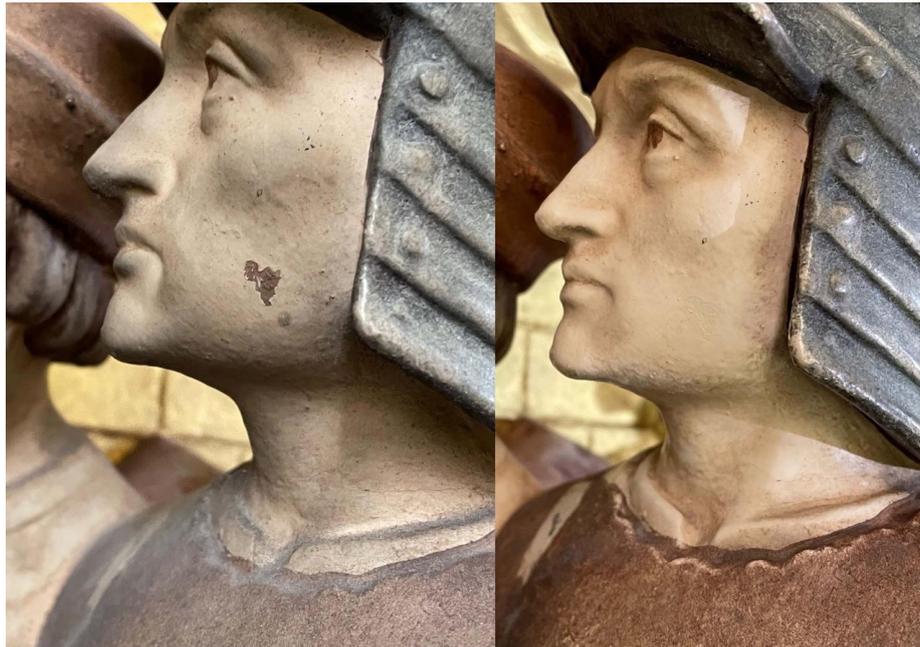
Figure 6: Before and after treatment of the in-painted area of paint loss

Other areas of paint loss were retouched to match to their surrounding areas. Paints were not used over the original material, extending only to the break edge. The principle of retouching is to replicate the original visual appearance of the object, so that it cannot be detected until under close inspection. This is important so that future conservators can identify previous interventions, whilst not falsifying the extent of original material.
